## Case Report Article

# Ceramic veneers failure: a repair and reintervention clinical report

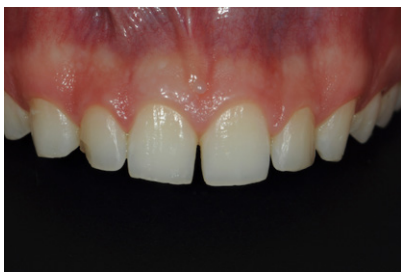
Figure 2 - Initial clinical situation

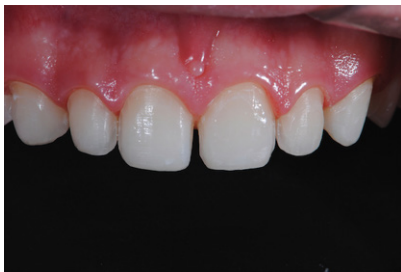
**Figure 3** - Front view after preparation

margin and facilitate positioning of the veneer during the cementation. All existing restorative material was removed using 12-fluted carbide burs (H375R; Cosmedent, Chicago, IL, USA). Tooth preparation was carried out using diamond burs (#2135F; KG Sorensen, Cotia, SP, Brazil) with the aid of the polyvinylsiloxane mold to keep the preparation minimally invasive (figure 3). The preparation was finished using #14 and #16 12-fluted burs (H375R; Cosmedent). Shade matching was performed using a value-oriented shade guide (Vita Bleachedguide 3D-MASTER, Vita Zahnfabrik, Bad Säckingen, Germany) and determined as 1M1. A single-step, double impression technique was performed using polyvinylsiloxane. The provisional veneers were made with the aid of a silicone mold obtained from the previously waxed cast. The mold was filled with bisacryl resin (Protemp 4; 3M ESPE, St. Paul, MN, USA) and inserted into the mouth until polymerization was complete.

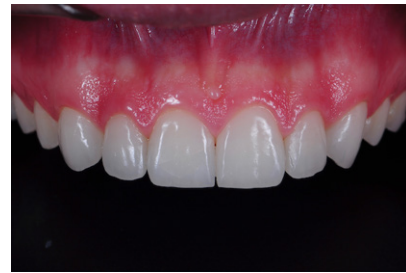
**Figure 4** - Aspect after luting

After isolating the operative field with cotton rolls and a suction device, the enamel was treated 37% phosphoric acid gel (Ultra Etch; Ultradent Products Inc.) for 30 seconds, rinsed and air-dried. A two-step adhesive system (Excite F DSC; Ivoclar Vivadent) was applied and gently air-dried for 5 seconds. The intaglio surface of the feldspar CLVs (VITA VM7; Vita Zahnfabrik) was etched with 10% hydrofluoric acid for 120 seconds (Condac Porcelana; FGM, Joinville, SC, Brazil), ultrasonically cleaned with distilled water and air-dried. A silane coupling agent (Monobond N; Ivoclar Vivadent) was applied for 60 seconds and air-dried. The CLVs were luted to the prepared teeth using a light-polymerized resin-based luting agent, shade 0 (Variolink Veneer; Ivoclar Vivadent). Figure 4 shows the clinical aspect immediately after luting.

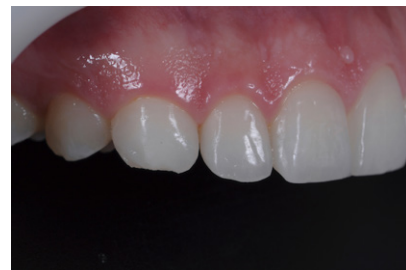
Seven months after luting the veneers, the patient complained about a fractured incisal edge on the maxillary right canine (figure 5). The decision was to repair it with composite resin. The operative field was isolated with cotton rolls and suction device, the fractured area of the ceramic was sandblasted with 50  $\mu$ m alumina particles (Bio-Art, São Carlos, SP, Brazil), followed by thorough washing and drying. The veneer was etched with 10% hydrofluoric acid for 120 seconds, the surface was rinsed and dried. Silane coupling agent was applied for 60 seconds and air-dried. The two-step adhesive system Adper Single Bond 2 (3M ESPE) was applied and the repair was carried out using a nanofilled composite resin (Filtek Z350; 3M ESPE) shade A1.

**Figure 5** - Maxillary right canine with fractured veneer

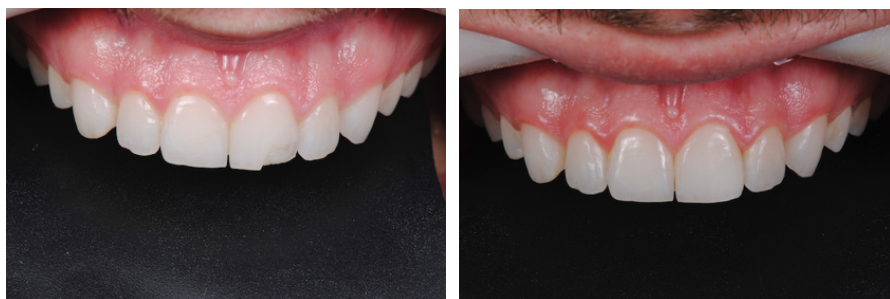
The patient returned 2.5 years after the repair on the maxillary right canine with the maxillary left incisor veneer fractured (figure 6A). A repair with composite resin (figure 6B) was performed following the same procedures described for the maxillary right canine. After 21 months since the second repair, the patient returned presenting pigmentation of the composite used to repair the maxillary left central incisor, chipping in the maxillary right lateral incisor, and stained cracks

**Figure 6** - Maxillary left central incisor with fractured veneer (A). Repair with composite resin (B)

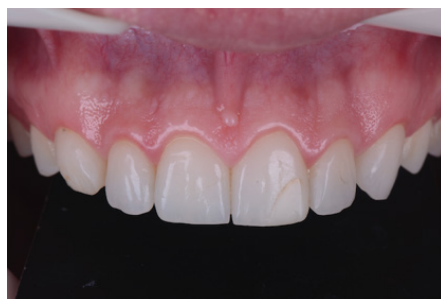
in the maxillary left central and lateral incisors (figure 7). At this moment, considering that almost 5 years had passed since the first fracture and the compromised esthetics, the choice was to replace the veneers. The new veneers were thicker, and the material chosen was a lithium disilicate-reinforced glass ceramic (e.max Press; Ivoclar Vivadent) in order to improve the mechanical strength. An impression was made, a cast was obtained, and a new diagnostic waxing was developed. The feldspar CLVs were removed using diamond burs (#2135F; KG Sorensen) and the preparation was polished with #14 and #16 12-fluted burs. A single-step, double impression technique was performed using polyvinylsiloxane. Provisional veneers were made with bisacryl resin.

**Figure 7** - Aspect 21 months after repair of maxillary left central incisor: marginal discoloration of composite and chipping in maxillary right lateral incisor

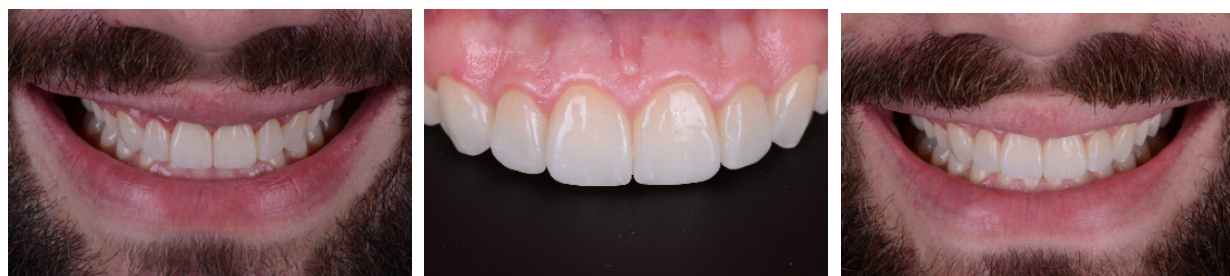
**Figure 8** - Aspect after luting new veneers (A). Approximate view (B). Eighteen-month follow-up evaluation (C)

The enamel was treated 35% phosphoric acid gel (Scotchbond Etchant; 3M ESPE) for 30 seconds, rinsed and air-dried. The three-step adhesive system (Scotchbond Multipurpose; 3M ESPE) was applied and gently air-dried for 5 seconds. The intaglio surface of the CLVs was conditioned with 10% hydrofluoric acid for 20 seconds, ultrasonically cleaned with distilled water and air-dried. A silane coupling agent was applied for 60 seconds and air-dried. The CLVs were luted to the prepared teeth using a light-polymerized resin-based luting agent, shade Clear (NX3; Kerr Dental, Pomona, CA, USA). The final esthetic and occlusal evaluation were performed after 7 days (figure 8A). A follow-up visit occurred after 18 months (figure 8B and 8C), the patient was satisfied with the treatment.
